STATE OF SOUTH CAROLINA)	IN THE COURT OF COMMON PLEAS
COUNTY OF RICHLAND)	Civil Action #: _____
)	
Karen Hoover Guay)	
Newfangled Consignments LLC)	
)	
v.)	<u>COMPLAINT</u>
)	(Jury Trial Demanded)
Estates Management Co.)	
WECO River District LLC)	
Robert Mundy)	
Carter and Carter Construction LLC)	
CBG, Inc)	
Terratec, Inc)	
GS2 Engineering Environmental Consultants, Inc)	
Hayward Baker, Inc)	
Modern Exterminating Co. Inc)	
Seamon Whiteside Inc)	
Stienburg Design Collaborative LLP)

RE: Structural Evaluation of 351 Meeting St.
C&A Project No. 583867-17

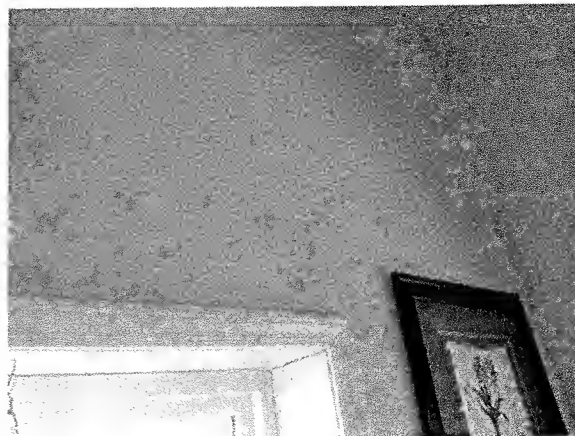
4 (before)

- 2 At the window on the front wall farthest to the left there was separation in the top left corner of the window molding and a hairline diagonal crack in the wall starting at this corner approximately 1' in length; above this same window an approximate 4' long and 1/8" wide horizontal crack was observed. This deficiency appeared between the December 4, 2017 and January 30, 2018 evaluations. All these cracks are getting wider and longer (see photos 4 and 5).

Due to the constraint of the surrounding structure, our previously recommended soil nail system into both walls in order to prevent any further settlement is not a viable option now. It is our opinion that the most efficient way to rectify the issue is to excavate the soil from inside the building and install steel beams vertically along the walls. The steel beams need to be epoxy bolted into the walls and secured at the top by the new poured concrete slab. During the excavation, all the existing interior walls need to be temporary shored to prevent collapsing and/or settlement. It is reported that there was a fuel tank abandoned underneath the building. Care should be exercised during the excavation to remove the fuel tank due to there may be hazardous material inside and around the tank. An environmental specialist shall be consulted to develop the procedure of removing the fuel tank. The entire building shall be vacated until the repair work is completely done. Only after both of these retaining walls are stabilized by the steel beam system should the above ground finishing repairs be made. This is a highly complicated repair project and finding a competent contractor could be a challenge. The contractor shall be required to have a Performance and Payment Bond to insure the proper repair work. The cost of performing the structural repair work only including A/E design is estimated at \$400,000.

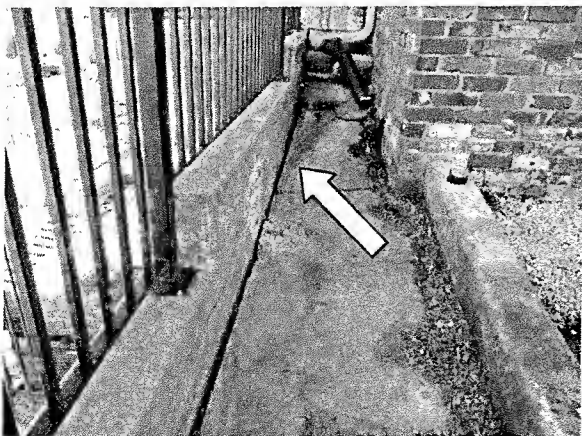
15 (before)

- 8 A separation was noted along the right face of the concrete retaining wall and the concrete curb/concrete splash pad. The maximum separation at the concrete curb was measured to be approximately 1-3/4" wide. This separation is getting wider (see photos 15 - 16). There is a new stair step crack developed at the lower portion of the left wall window (see photo 17).

It is our opinion that the above noted deficiencies are a result of further/continuous settlement in the left side of the building and the rear right corner of the building. The existing soil around the building was there to provide stability for the concrete retaining wall and building basement wall. When the soil surround the left and rear sides of the building were continuously eroded away by the stormwater runoff created by the adjacent construction activity, it has further aggravated the outward deflection of the concrete retaining wall and basement wall thus causing the soil behind to settle further.
